integrity
Forensics & Engineering

120 Volt Household Current Testing on Corrugated Stainless-Steel Tubing Types and Schedule 40 Black Iron Gas Piping.

Prepared For: National Association of State Fire Marshals
PO Box 948238
Maitland, FL 32794

February 16, 2018

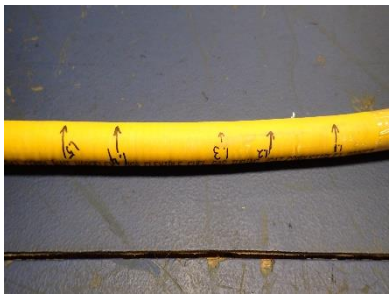
Figure 11 The five test locations.

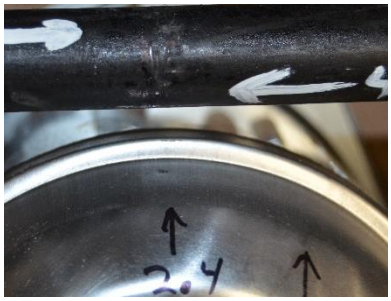
When energized, the circuit faulted and tripped the circuit breaker. Both the recessed light fixture's housing and the BIP sustained minor surface damage at the point of contact.

No perforations occurred in either the recessed light fixture or the BIP throughout this series of testing.

Figure 18 Result of Test 2.1.

Figure 19 Results of Test 2.4.

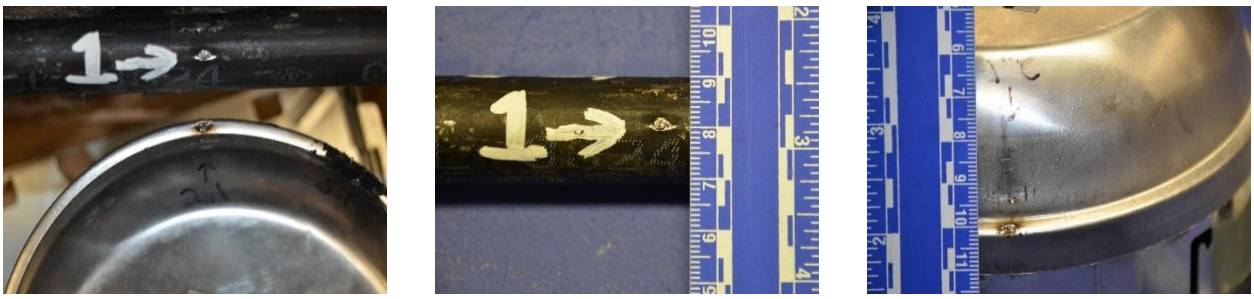
Figure 20 Test 2.1 post-test damage.

When the light switch was turned ON, an arc occurred between the light fixture housing and the gas pipe. The circuit breaker did trip, de-energizing the circuit without perforating the gas pipe. The recessed light fixture's metal housing sustained minor surface damage in the form of a small arc mark, accompanied by localized discoloration. The black iron pipe also sustained a corresponding arc mark.

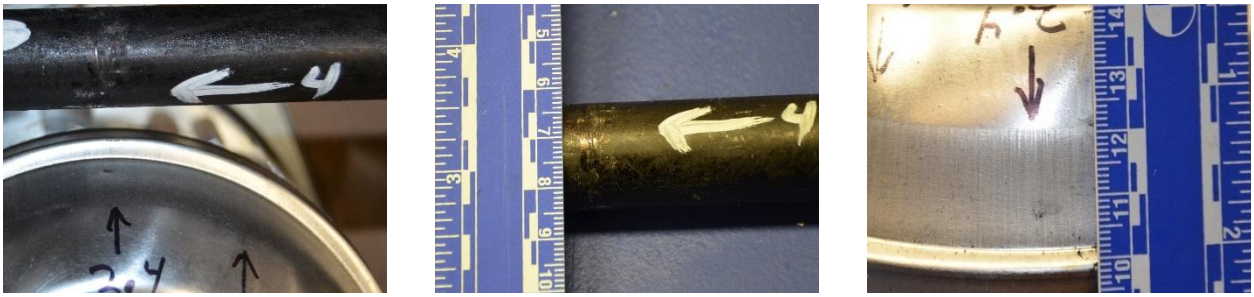
Figure 23 Test 2.4 post-test damage.

When the light switch was turned ON, an arc occurred between the light fixture housing and the gas pipe. The circuit breaker did trip, de-energizing the circuit without perforating the gas pipe. The recessed light fixture's metal housing sustained minor surface damage in the form of a small arc mark, accompanied by localized discoloration. The black iron pipe also sustained a corresponding arc mark.

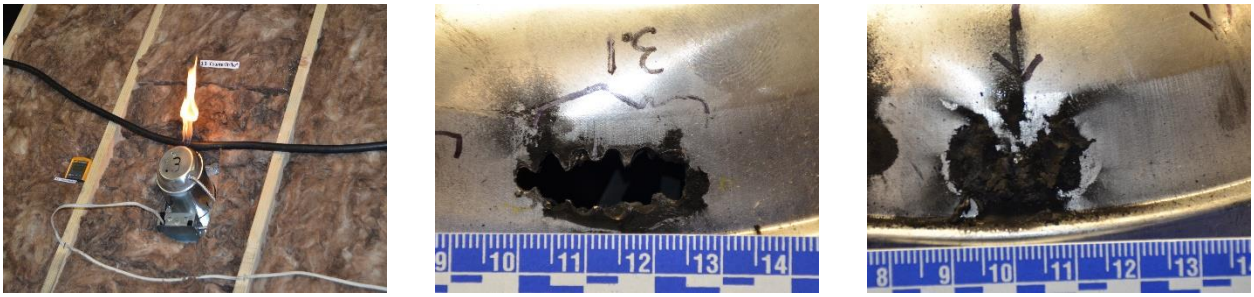
Figure 26 Example of fire resulting during test series 3 (left). Range of damage incurred to light fixtures across test series 3 (center & right).

When energized, arcing occurred between the gas pipe's outer jacket and the recessed light housing. The circuit faulted and tripped the circuit breaker. Both the recessed light fixture's housing and the CounterStrike® CSST sustained damage. The damage varied, from perforations spanning approximately 6 corrugations in length, to unperforated pits on both the CSST and the light fixture.

Perforations occurred in both the recessed light fixture's metal housing and the CounterStrike® CSST in 4 of the 5 tests. Once perforated, the flow rate for the escaping gas was measured before moving the gas pipe.

Fires resulted in 4 out of 5 tests within this series.

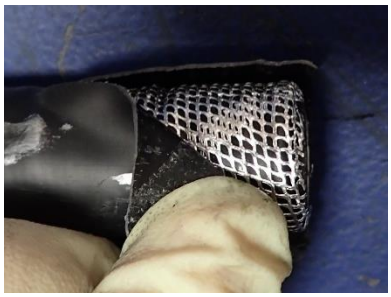
Neither the recessed light fixture's housing nor the FlashShield™ CSST sustained any damage.

No fires resulted.

Figure 41 FlashShield™ CSST aluminum mesh layer visible.

Figure 42 FlashShield™ CSST in contact with recessed light fixture.

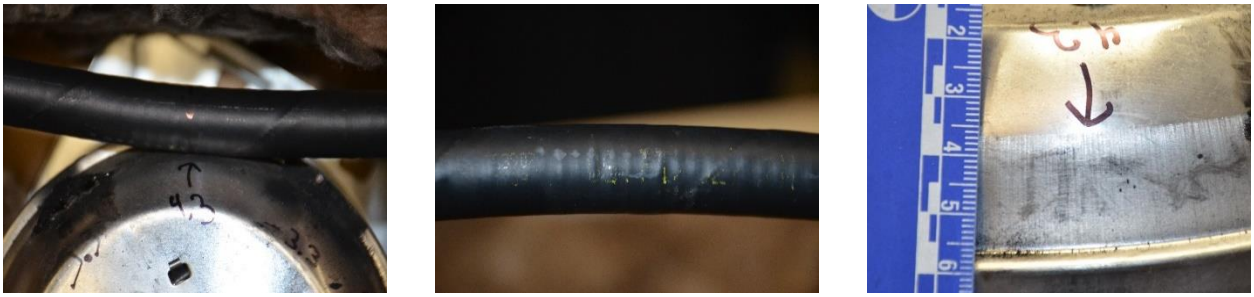
Figure 45 Test 4.3 in place (left). Undamaged FlashShield™ (center) & light fixture (right) post-test.

When the light switch was turned ON, the light came on, but there was no electrical activity. The circuit breaker did not trip. Neither the recessed light fixture's housing nor the FlashShield™ CSST sustained any damage.

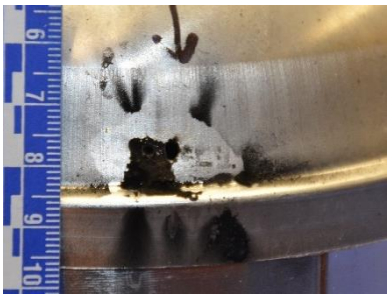
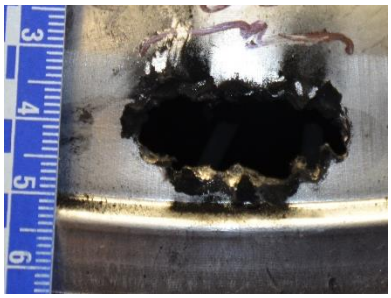
Figure 49 Example of fire resulting in test series 5 (left). Range of damage to light fixtures in series 5 testing (center & right).

When energized, arcing occurred between the gas pipe and light fixture's metal housing. The circuit faulted and tripped the circuit breaker. Both the recessed light fixture's housing and the WARDFlex® Max CSST sustained damage. The perforations ranged in damage from approximately 3 to 11 corrugations.

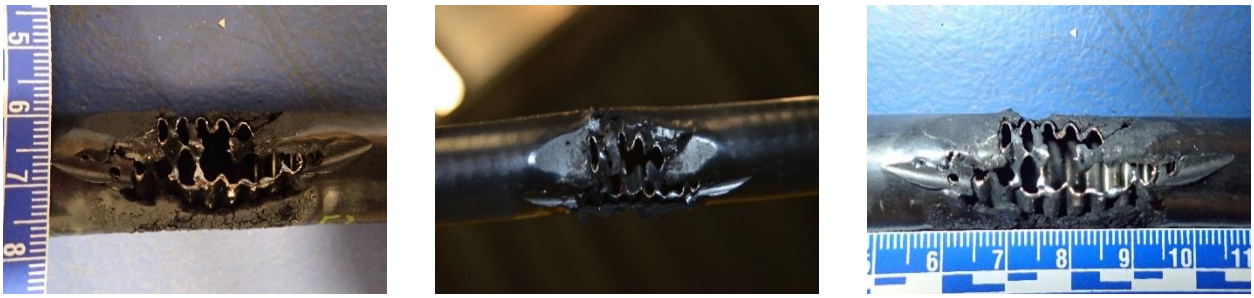
Test 5.1

Figure 51 Damage to WARDFlex® Max CSST in test 5.1.

Figure 52 Damage to light fixture in test 5.1.

The recessed light fixture's metal housing sustained damage, leaving a series of holes matching the corrugations of the CSST gas pipe. The damage stretched approximately 11 corrugations in length.

The WARDFlex® Max CSST gas pipe sustained damage. The perforations stretched approximately 11 corrugations.
